Excavations at the Priory of St. Mary Magdalene of Lund, Monk Bretton

HUGH WILLMOTT AND PETER TOWNEND

University of Sheffield, UK

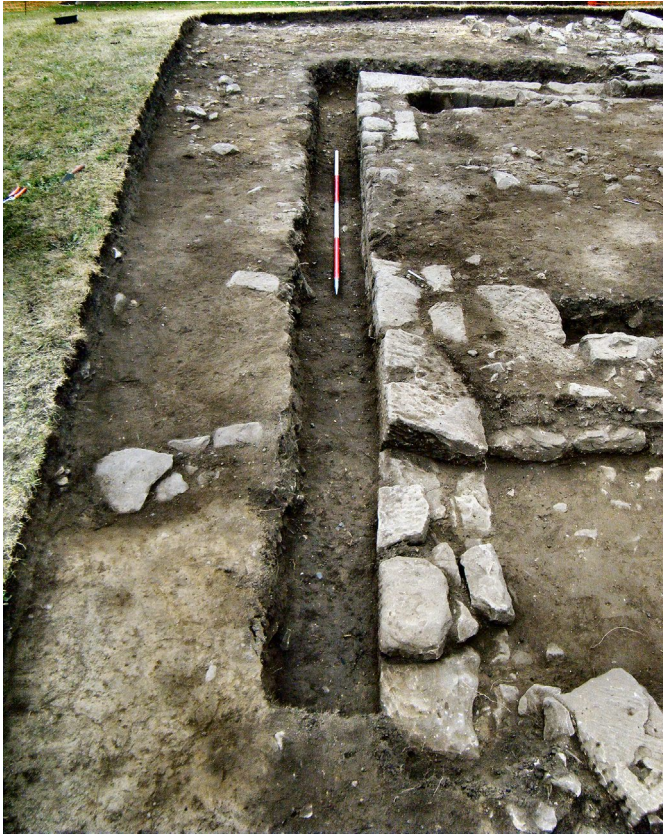
FIGURE 4 Re-excavated ministry of works wall-chasing cut.

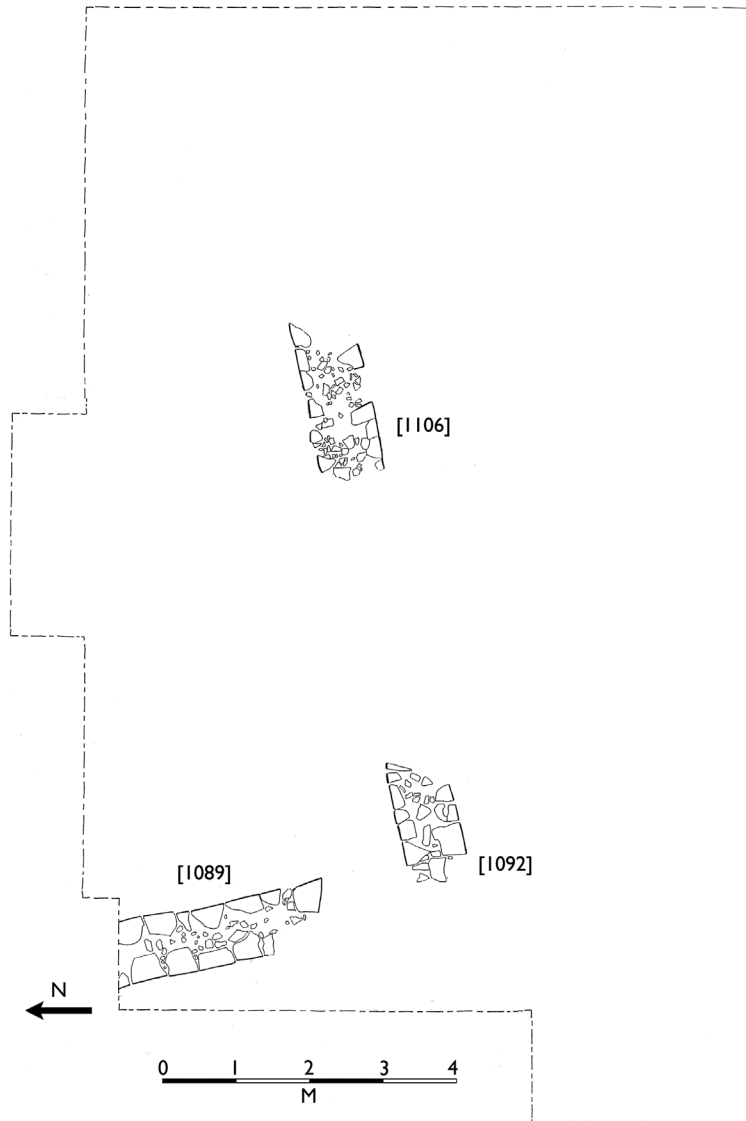
FIGURE 5 Phase 1 walls.

The only archaeological features relating to this phase are three disjointed sections of wall, although their alignment and similar construction strongly suggest they are closely related (Fig. 5). Two fragments, [1089] and [1092] were located in the centre of the trench both on the same ENE-WSW alignment. Both sections only remained to the height of

a single course and it was clear that these had been intentionally demolished when the area was completely remodelled during Phase 2. The third wall section, [1106], was in the north-west corner of the trench on a NNW-SSE alignment, placing it perpendicular to the others. This wall survived to the height of four courses, as it was incorporated into the later Phase 2 and Phase 3 buildings. It also apparently survived, at foundation level at least, well into the twentieth century, where it is visible on both earlier OS maps and photographs as the wall running north to join the south-east corner of a still-standing building.

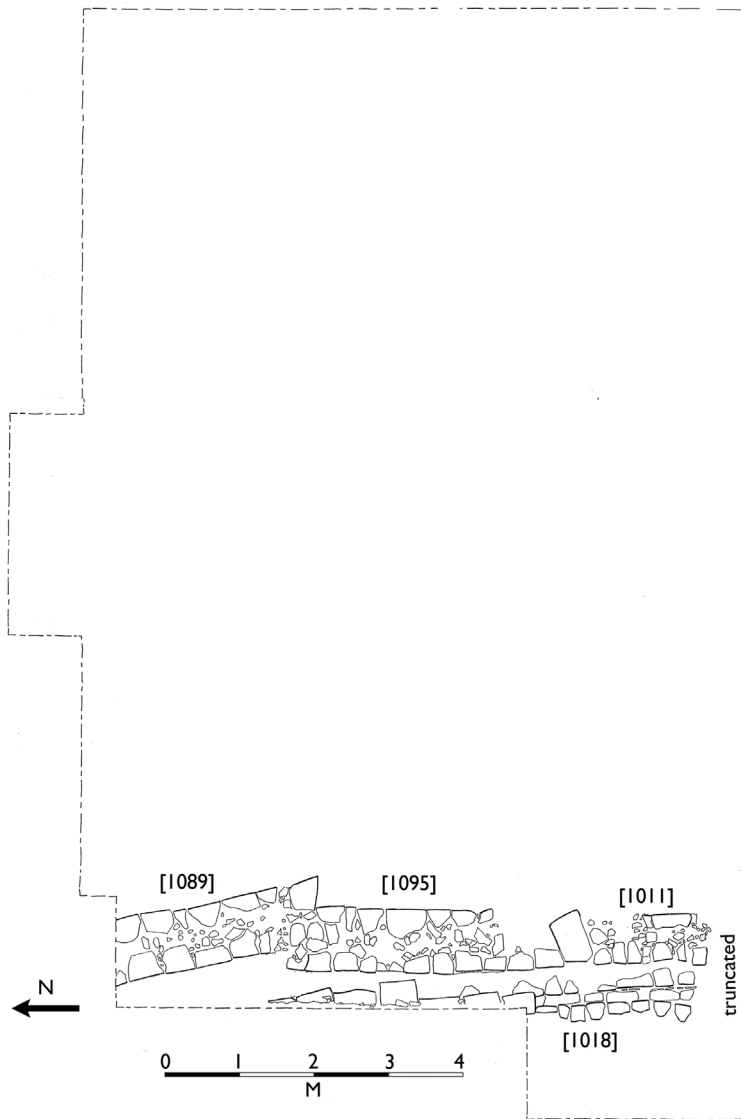
FIGURE 8 Phase 4 features.

Very little activity seems to have taken place in the area of the trench between the late sixteenth and nineteenth centuries (Fig. 8). As mentioned above, walls [1095] and [1084]

seem to have been the only structural elements that survived above ground during this period. These were further extended to the south by a section of slightly thinner wall [1011], which was placed in a cut [1022]. At the same time this new section of wall was built, a new capped drain [1018] was also positioned parallel to the west of [1011] and running north alongside the reused wall [1095]. On excavation this was found to contain fragments of eighteenth-century Blackware as well as some small sherds of earlier ceramic that had presumably been washed into the drain.

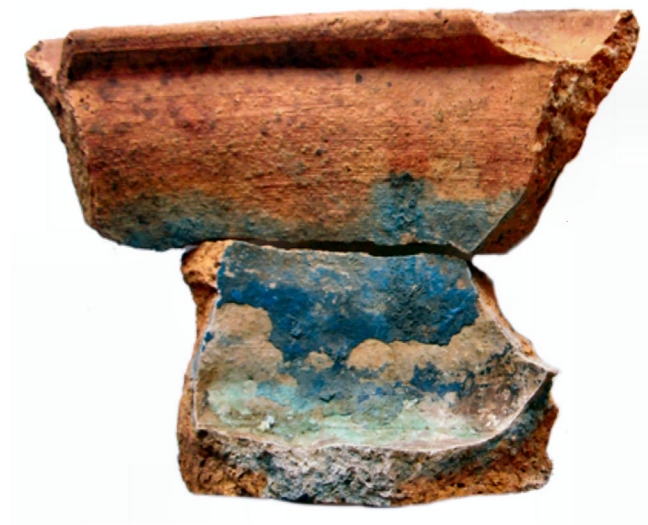
FIGURE 9 Cucurbit with copper arsenate deposit (1:1).

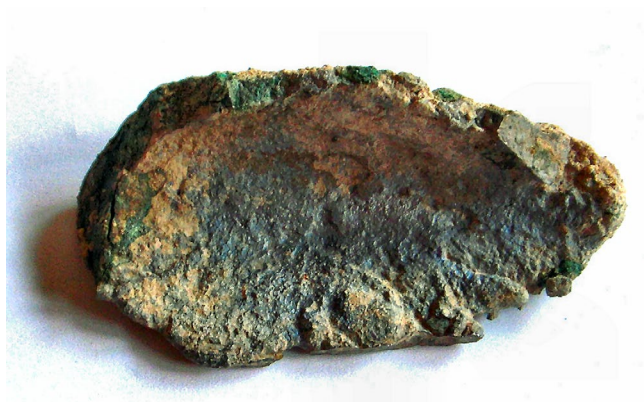
FIGURE 10 Fragment of melted 'bell metal' from Trench 1 (1:1).

copper alloy (apparently mirroring the shape of a crucible in which it had been melted) was recovered, and probably belonged to this initial Dissolution period (Fig. 10). XRF analysis showed it to be made from a tin-rich bronze that also included elevated levels of lead (R. Doonan pers. comm.). This composition was typical of medieval bell metal but also used for other vessels such as mortars, holy water stoops and other liturgical vessels (Blair & Blair 1991, 82–3).

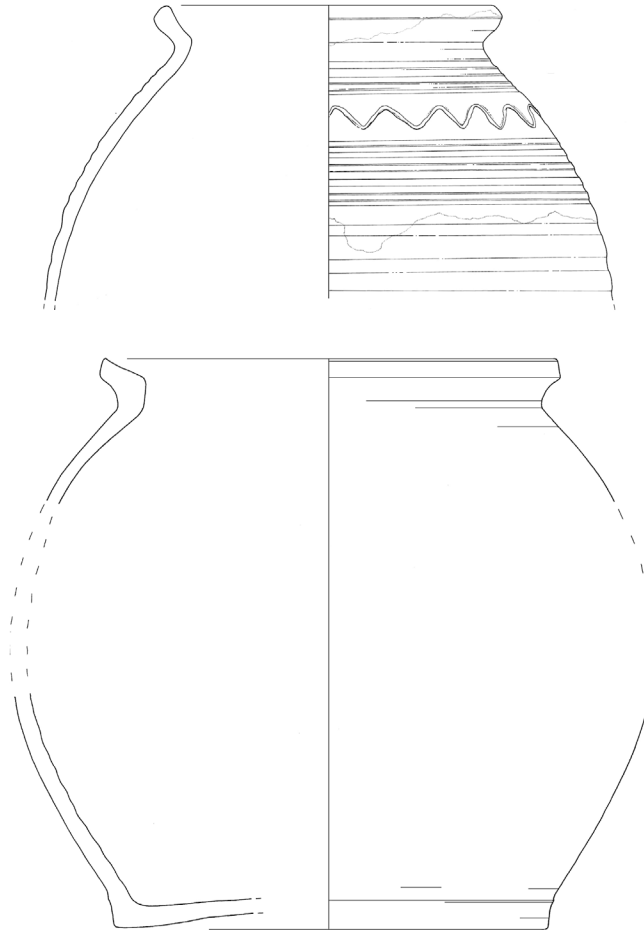
FIGURE 11 Ceramic coursewares (1:3).

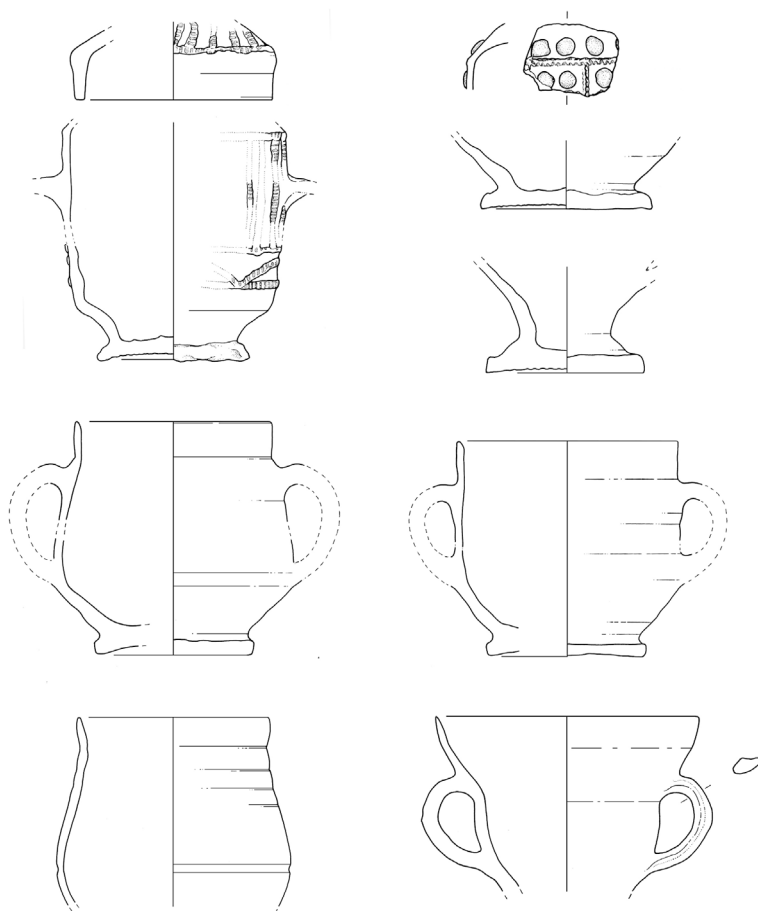
FIGURE 12. Cistercian wares (1:3).

The early post-medieval fabrics represented also largely originate from the South Yorkshire area. The decoration on many of the Cistercian ware vessels, including a pos-set pot lid and type one drinking vessel (Fig. 12) have clear parallels with similar vessels from a number of South Yorkshire production sites including Wrenthorpe and Silcoates, near Wakefield and Pothills, near Doncaster (Brears 1983, 217, Fig. 93.1; Boyle 2006, 127), although others may have originated from further afield. The presence of continental imports in the form of Rhenish stoneware from the Rhine valley and a Martincamp vessel from Northern France is unsurprising as these are relatively common on middle to high status sites of this period, including Sandal and Pontefract Castles (Moorhouse 1983, 155; Cumberpatch 2002, 194–195).

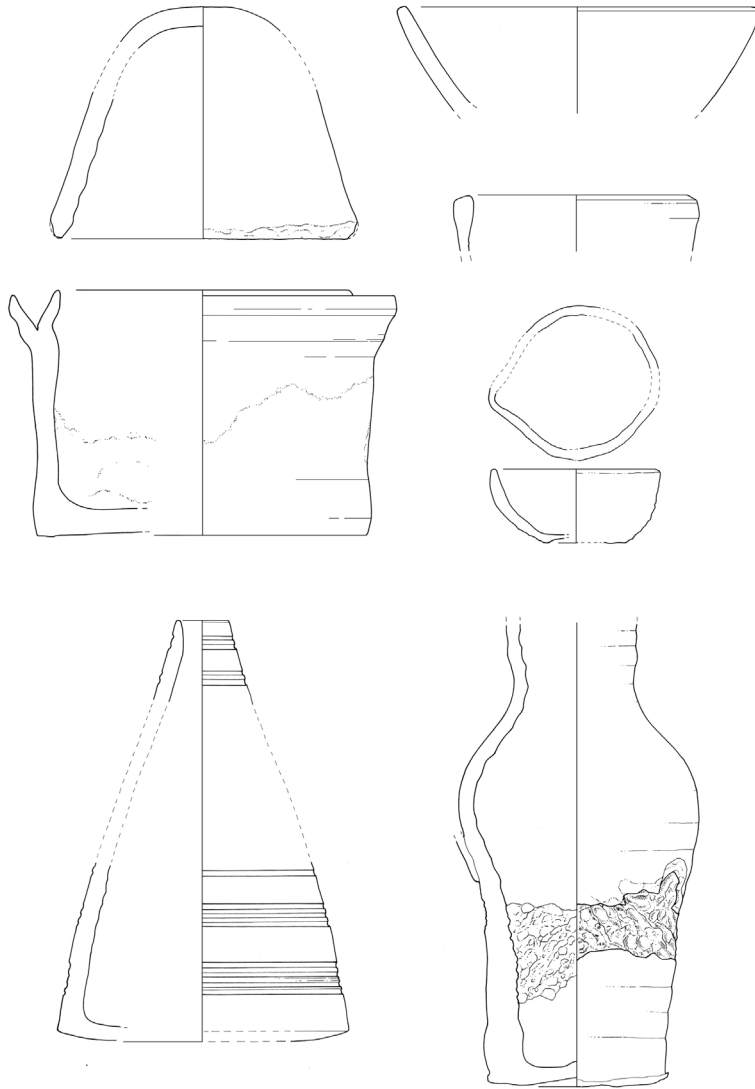
FIGURE 13 Industrial ceramics (1:3).

The industrial assemblage originates largely from a single, late medieval context, [1062]. It consists of at least seven vessels, six of which are largely complete, and is clear evidence of alchemical activities within the excavated area during the late medieval

period (Fig. 13). Vessel forms are closely paralleled by those at Sandal Castle (Moorhouse 1983, 191–194) and include crucibles, cucurbits and straight sided jars. Industrial assemblages have also been identified at a number of other monastic sites, including Pontefract Priory where, as at Monk Bretton, small jugs were also included within the assemblage (Moorhouse 1972, 96). However, unlike Pontefract Priory and Sandal, only one possible Humberware vessel has been found, with the majority of vessels being manufactured from Coal Measures White and Purple. In addition, one vessel is almost certainly an alembic, a form which is rare within industrial assemblages as this vessel type is more usually manufactured from glass (Moorhouse 1983, 194).

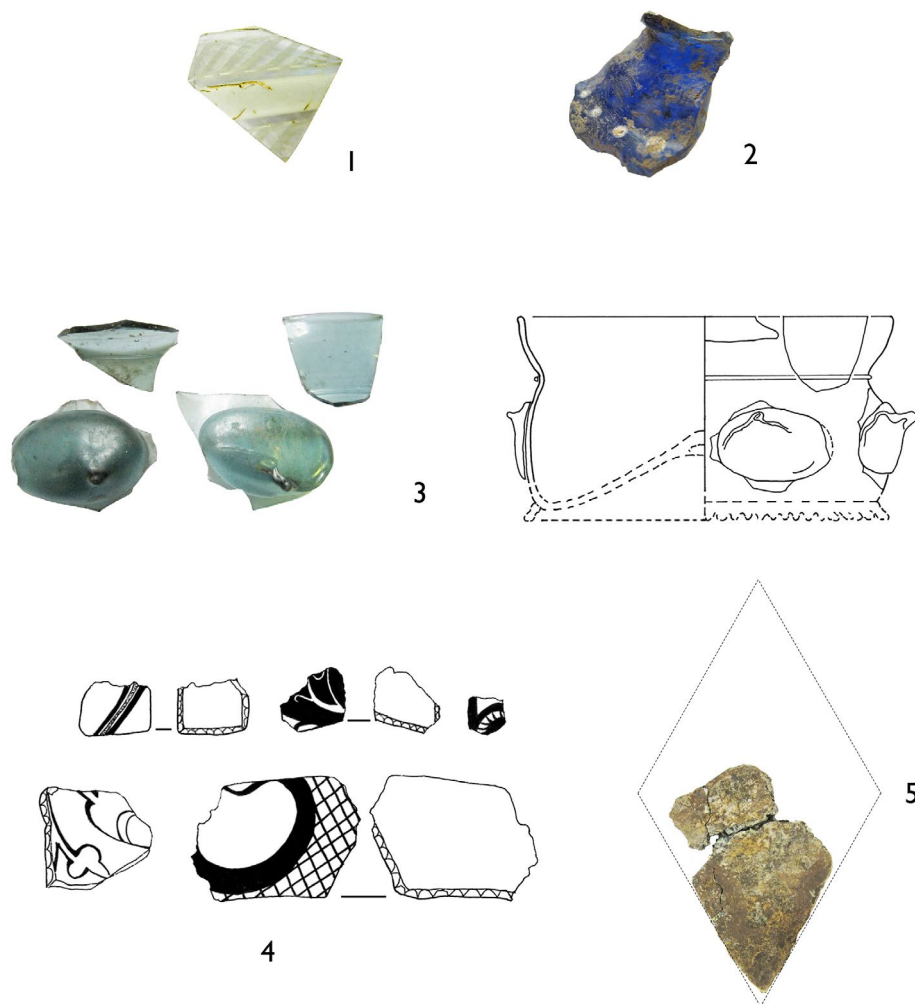
FIGURE 14 Glass (Nos 1–2 1:1, Nos 3–5 1:2).

de Venise soda glass drinking vessel, decorated with opaque white marvered trails, in a *vetro a fili e retorti* style (Fig. 14). This fragment almost certainly came from a goblet bowl dating to the first half of the sixteenth century, and is of continental origin, although due to its small size it is not possible to reconstruct its form further. The second drinking vessel was found in context (1015). The fragment is deep cobalt blue, relatively thick (4 mm), and comes from a folded base of a pedestal beaker or goblet. It is further decorated with four white enamel dots running around just above the now lost tubular base-ring. Being only a small fragment it is difficult to date precisely, but this type of deeply coloured pedestal vessel usually dates to either the late fifteenth or first half of the sixteenth century (Willmott 2002, 70–2). The third drinking vessel is a large mid-fifteenth

Seventeen pieces of painted window glass were recovered (Fig. 14). Most of the painted glass fragments were too degraded to interpret their design. Exceptions were two larger pieces painted with grisaille fronds and with cross-hatched backgrounds, with one clearly being from a diamond-shaped quarry. Two pieces of blue glass were also recovered from contexts (1000) and (1034), the latter of which was decorated with a series of curving lines, possibly from painted fabric or foliage. Other coloured pieces included a dark green fragment, which may have been painted, and a very tiny fragment of ruby flashed glass, both from context (1023).

Although not glass artefacts, a brief discussion of lead comes is included here given the direct connection it has with the window glass (Fig. 14). 31 fragments of lead comes were recovered from twelve contexts (Fig. 15). These 'H'-shaped lead bars were used for connecting glass quarries into a larger glazing scheme. All the fragments are small, varying in length from approx. 15 mm to 120 mm.

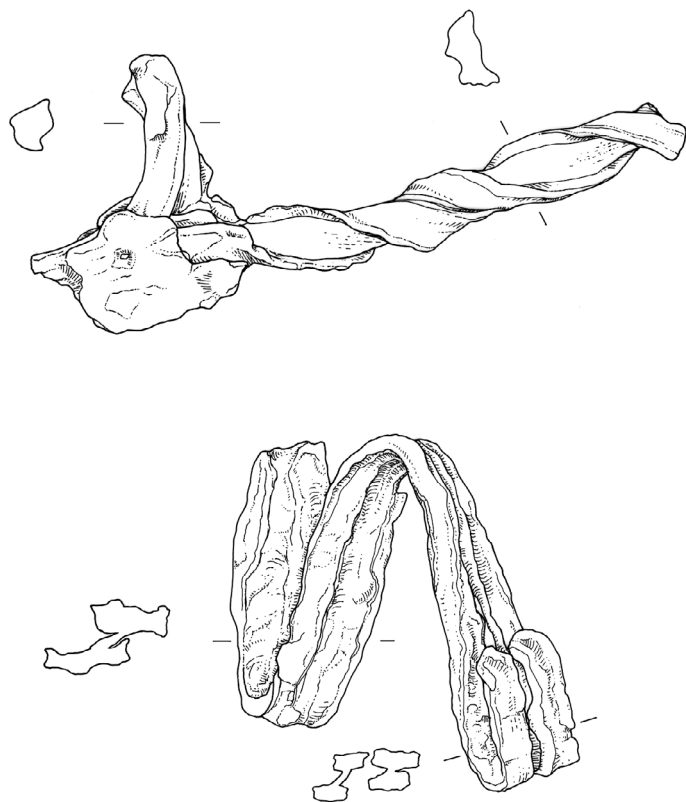
FIGURE 15 Twisted window leads (1:2).

Several pieces from Context (1085) demonstrate cut or crimp marks, and the largest piece is notably twisted and torn open at one end. This indicates that several pieces were likely to have been violently pulled or cut from the glass, probably during the demolition of the church, or as part of the intentional recycling of materials after the Dissolution.

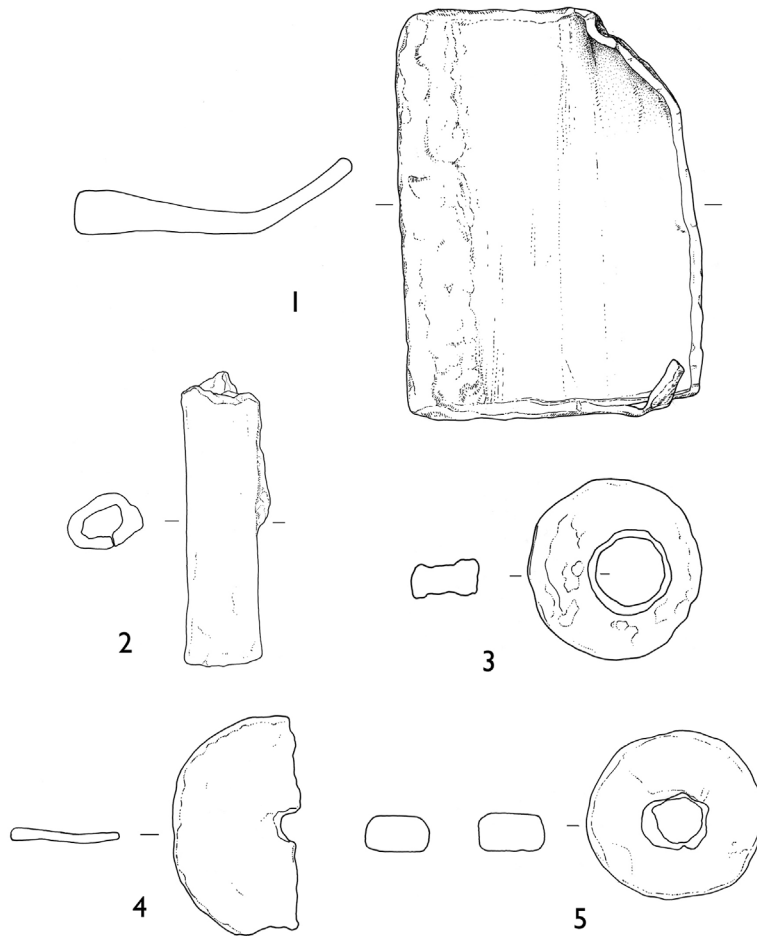
FIGURE 17 Lead finds (excluding window comes) (1:1).

A sub-rectangular sheet of roofing lead. The sheet is bent along its length and on two corners. Probably of late medieval date (Fig. 17).

An incomplete circular lead alloy disc, possibly a button. The disc is broken across its diameter and contains a small circular central hole for attachment. This artefact possibly dates to the late medieval period but is more likely to be of post-medieval date.
